## FITTING INSTRUCTIONS

Code: 231

Application: Honda/Acura Civic, Integra, CR-V 2001-on.

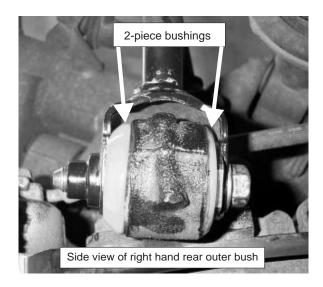
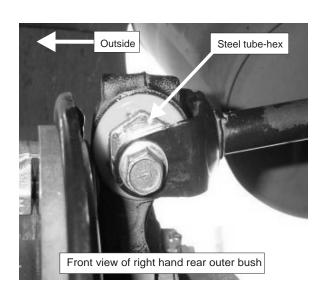
Positioning the <u>off-set hole towards the centre</u> of the car will adjust the existing camber by up to <u>positive</u> 0.75 degrees.

Positioning the <u>off-set hole towards the outside</u> of the car will adjust the existing camber by up to <u>negative</u> 0.75 degrees.

- 1. Check wheel alignment settings, and work out the amount and direction of camber change required.
- 2. Raise the vehicle, support on safety stands and remove rear wheels.
- 3. Remove the bolt holding the rear upper control arm to the wheel hub, and disconnect the control arm from the wheel hub.
- 4. Remove the original bushings from the wheel hub and push in new supplied bushings
- 5. Using supplied grease, grease ID and bushing face. Install the supplied offset steel tubes. NOTE:

- 5. Reconnect the control arm back to the wheel hub, and tighten all bolts to manufacturer's specification.
- 6. Refit wheels and lower the vehicle.
- 7. Road test, check wheel alignment and adjust if necessary. Camber adjustment can be made by loosening the upper control arm-outer bolt and rotating the hex on the supplied metal tube until desired camber setting is achieved. Retention all fasteners to manufacturer's specifications.
