Superior Engineering Installation Instructions

Part Description: Landcruiser 80/105 Castor Plates
Part Number: LCR5CP

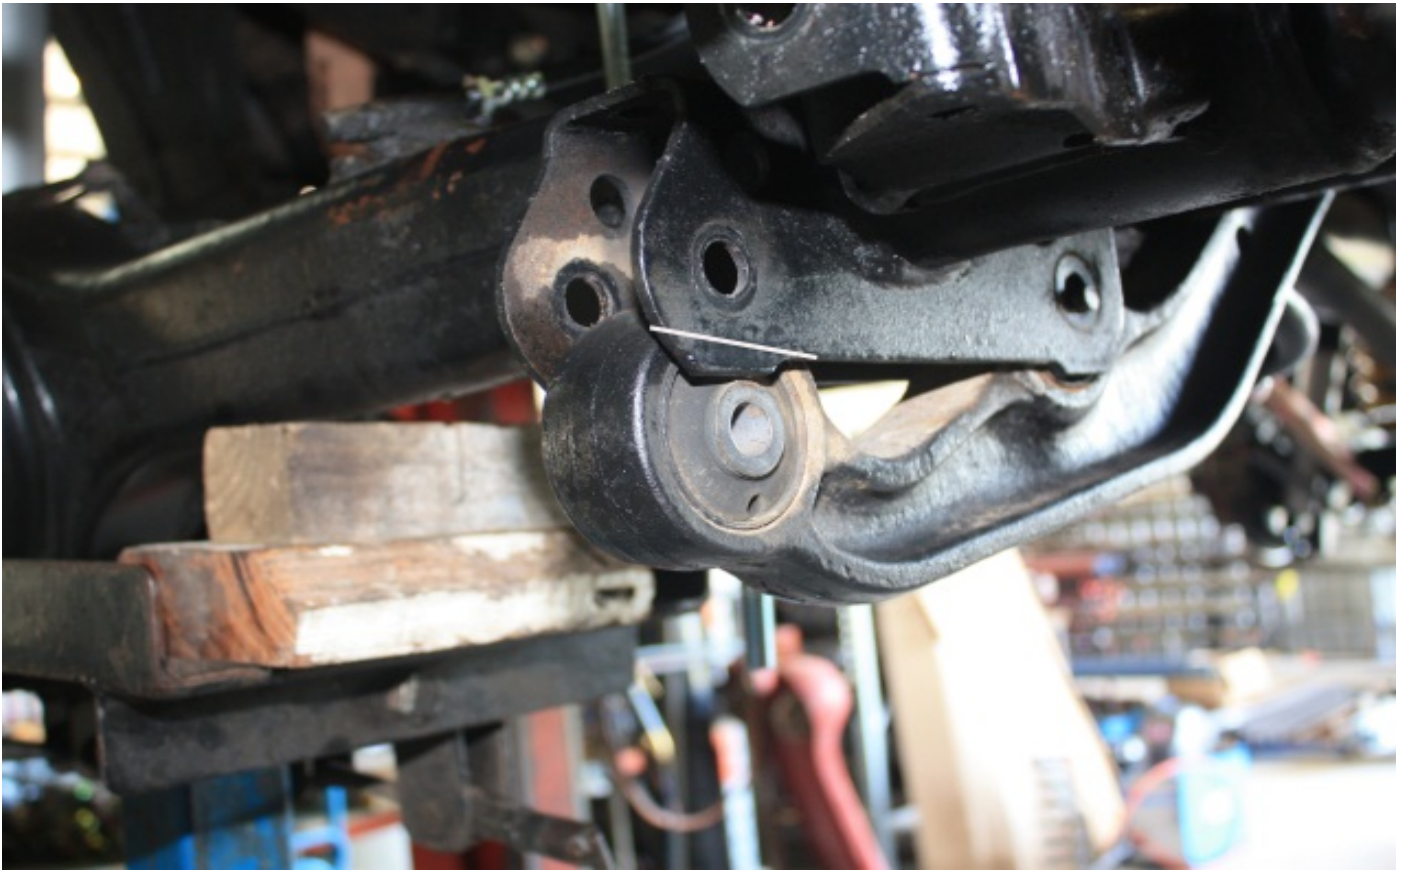
Figure 1: note cut line in white

2. Remove ONLY the front bolts from both Radius arms.
NOTE: The white line on the diff plate in Figure 1, shows the approx area that needs to be trimmed off with a grinder.
3. With the diff supported by a gearbox stand or similar, starting on the passenger side remove the nut on the rear and place the correct castor plate on.
NOTE: This is the best way to get an idea of how much to trim off the diff plate.
4. The castor plate must be up enough to line up the top bolt hole in the diff plate and the castor plate.

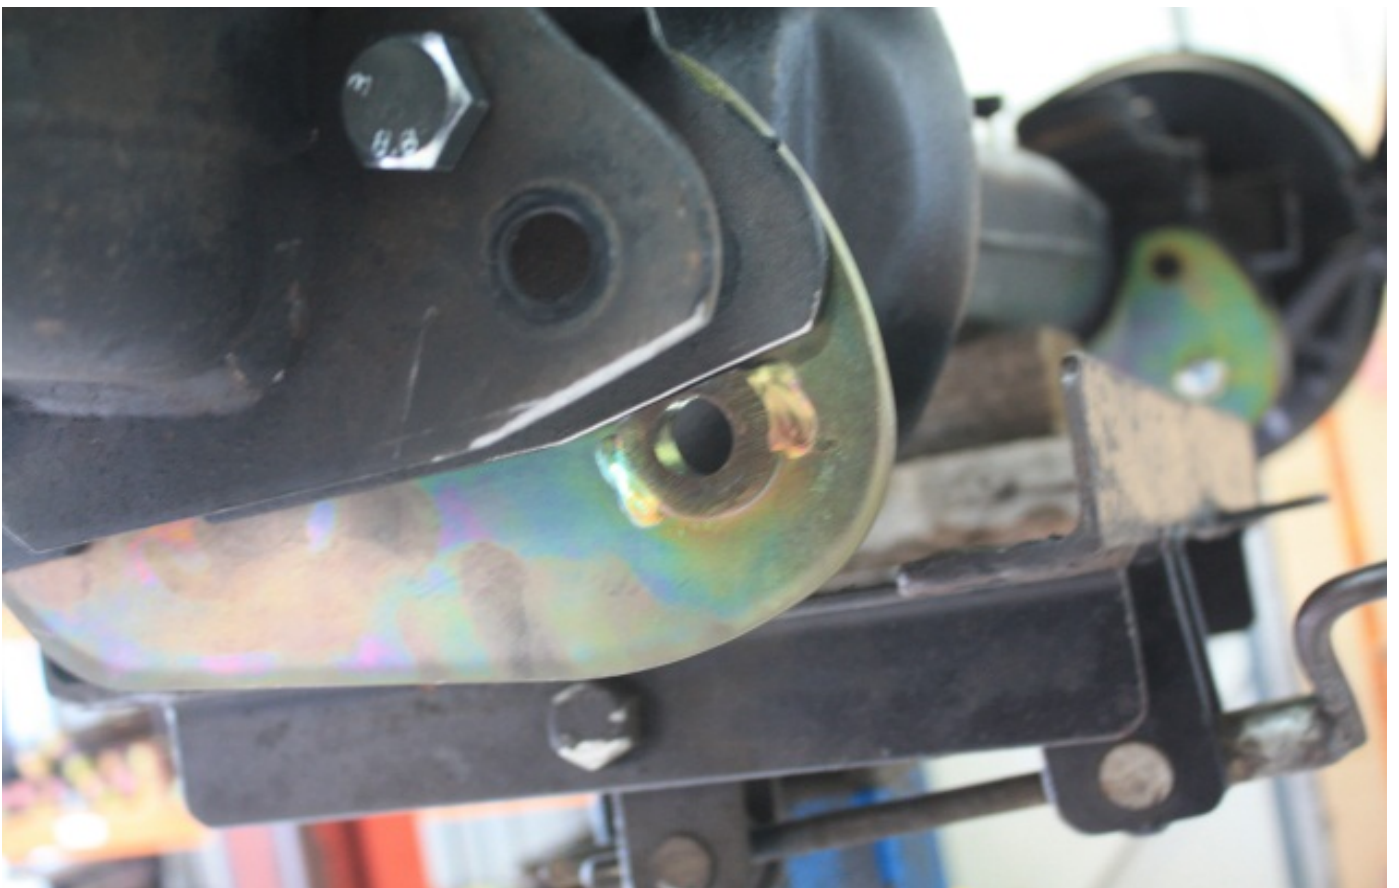
Figure 2: NOTE Half washer hard against cut diff plate

Figure 2 shows the plate fitted and note how the half washer sits under the diff housing when cut.

NOTE: see how the top bolt fits through the diff plate and the castor plate and with the trimming done the "half washers are up hard against the plate that was cut.

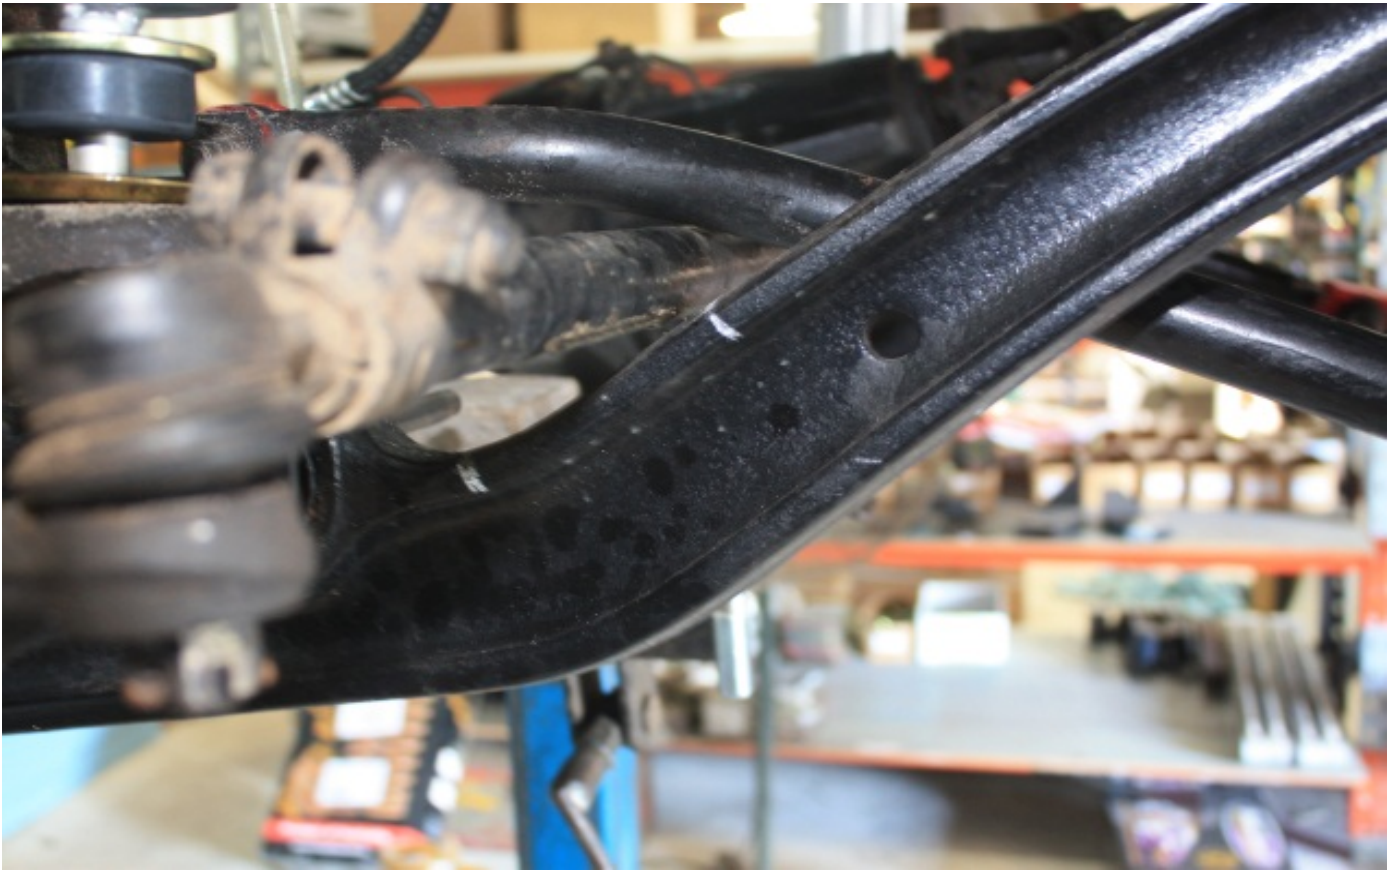
Figure 3: NOTE white marks on radius arm.

Figure 3 shows two white marks that are an approx. area that may need to have a slight grinding to the top casting area.

After marking the approx. area on the radius arm that needs to be ground remove the radius arm and place in a vice, carefully grind only enough to allow the clearance needed.
